PB 286 143
TECHNICAL NOTE
ORP-75-1

A SURVEY OF THE FARALLON ISLANDS 500-FATHOM RADIOACTIVE WASTE DISPOSAL SITE

THE UNITED STATES
ENVIRONMENTAL PROTECTION AGENCY

DECEMPER 1975

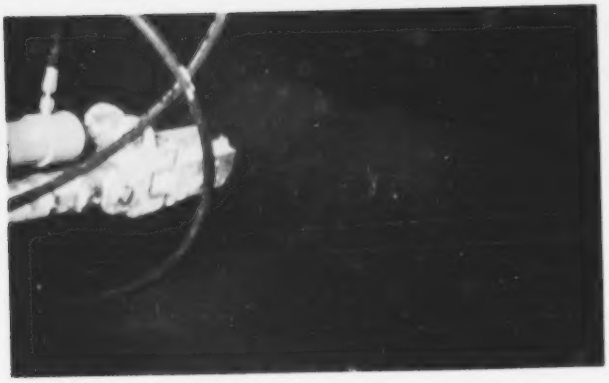
FRAME 357

Frame 357 — Fifty-five gallon radioactive waste barrel showing a moderate amount of hydrostatic crushing. A wire lifting eye is protruding from the concrete cap at the left end of the barrel. A deepsea sole, Embassichythys bathybius, is occupying the upper indented area.

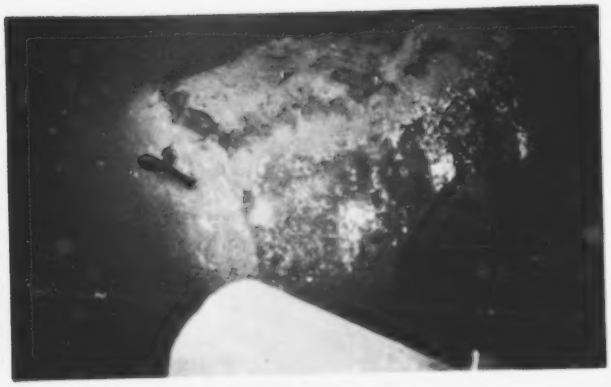
FRAME 374

Frame 374 Barrel in foreground shows effect of hydrostatic pressure in warping the length of the barrel. An anemone is attached to the concrete cap. Another barrel with a lifting eye is seen in the background.

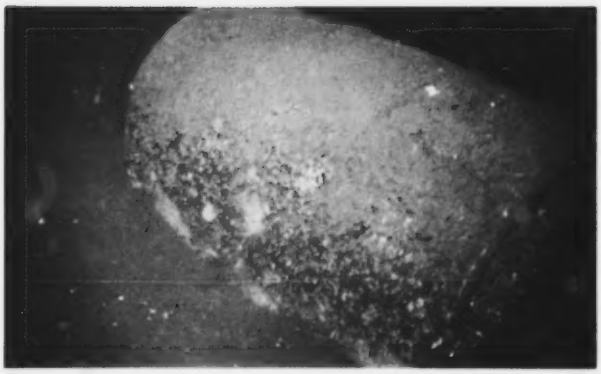
FRAME 379

Frame 379 View of underside of barrel that was rolled over. Good view of lifting eye in the concrete cap. Black deposits (sulfides) typical of anoxic corrosion are visible and appear to start a short distance below the sediment surface.

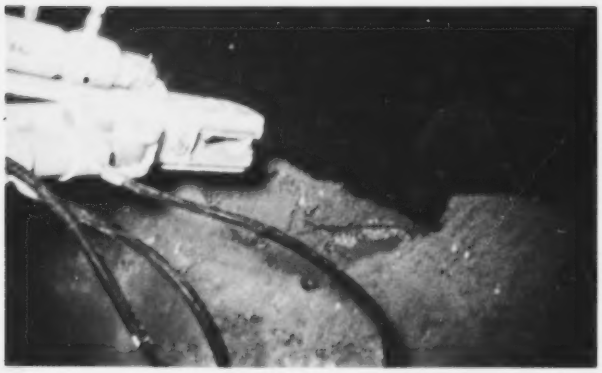
FRAME 388

Frame 388 A barrel with no evidence of hydrostatic crushing. A coating of fine, minimally disturbed sediments is prominent on the upper area of the barrel indicating the relatively small amount of sediment deposited since disposal 22 to 24 years ago. The metal cap (bottom) end of the barrel is at the lower right of the photo.

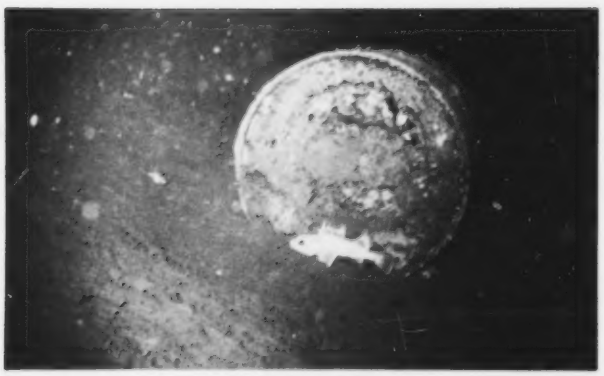
FRAME 415

Frame 415 — An example of the extensive hydrostatic crushing some barrels exhibited.. Implosion of most barrels was in the center third as shown here.
